# DAM SAFETY INSPECTION REPORT

West Milton Low Head Dam  
File Number: 9742-003  
Class III  
Miami County, Union Township  
Inspection Date: December 30, 2009

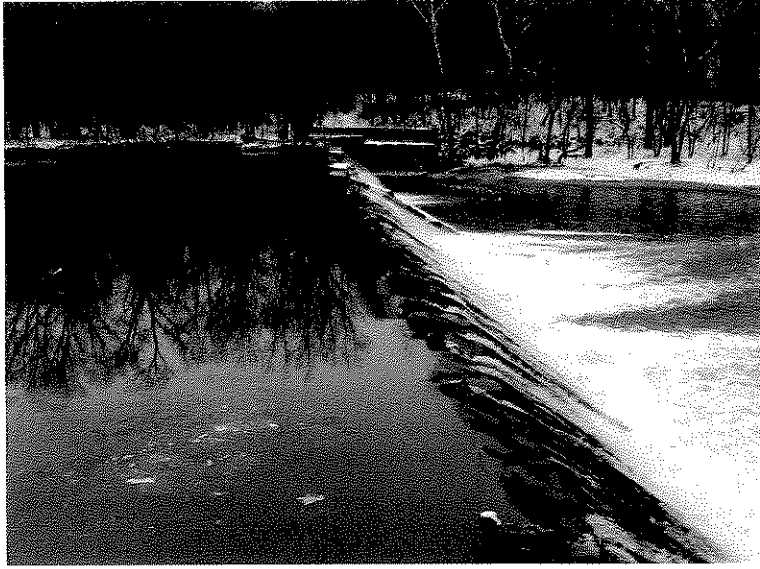
Photograph No. 1:

Crest of the structure looking toward the left end of the dam. The crest of the dam varies in elevation due to deteriorated concrete along the crest.

⇒ *Some portions of the concrete crest had deteriorated to approximately 4 inches below normal pool.*

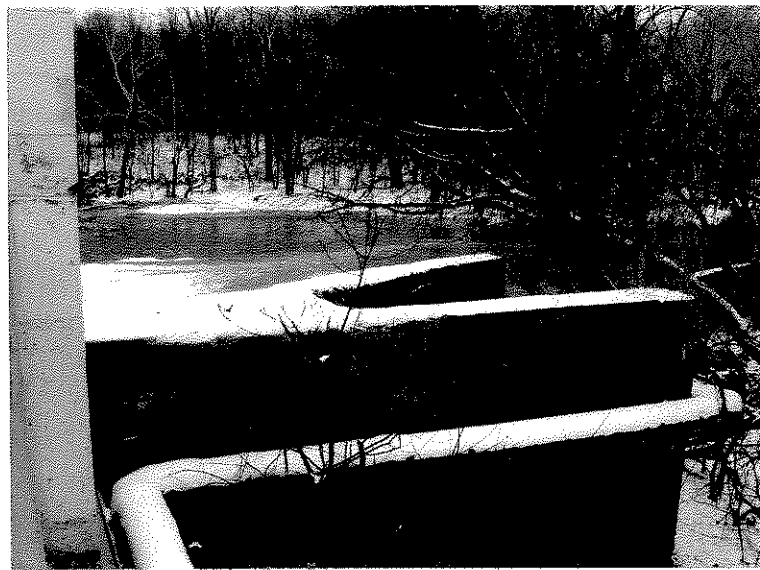
Photograph No. 2:

Endwall on the right end of the dam. The endwalls generally prevent flow from escaping onto the right and left abutments for typical river flow.

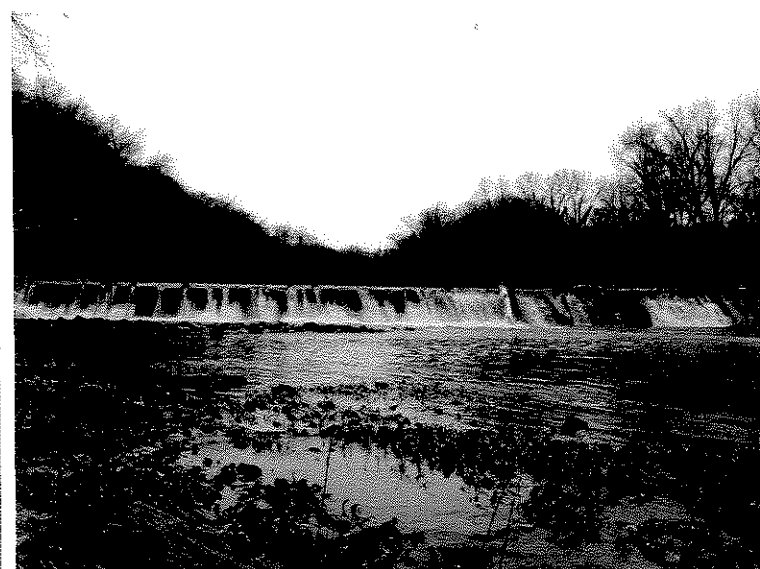
Photograph No. 3:

Overview of the downstream face of the structure.

⇒ *portions of downstream face severely deteriorated. Spalling, cracking and efflorescence noted along entire downstream surface. See photos for overview of condition.*

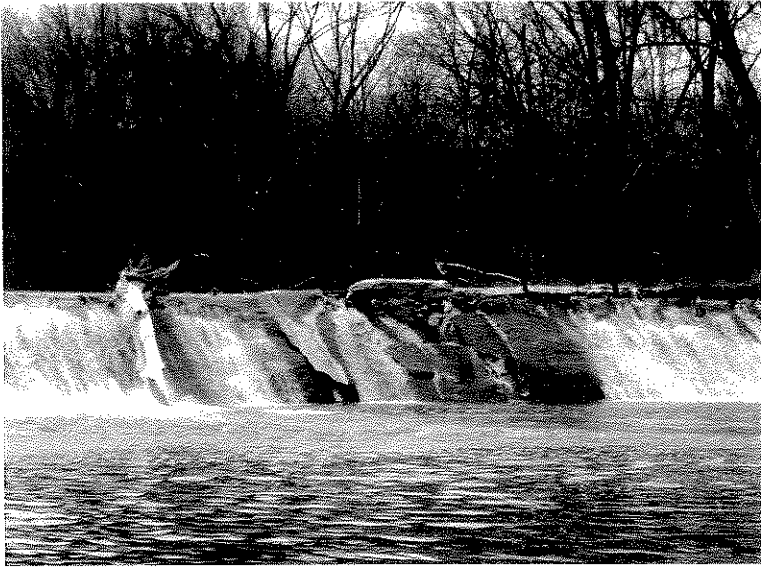
Photograph No. 4:

Flow through a deteriorated spillway subjects it to further deterioration and potentially failure. *Concrete deterioration was noted on the downstream face of the dam and in some sections of the dam is severe. Monitor the entire structure for any signs of rapidly deteriorating concrete. Severely deteriorated concrete must be repaired in order to prevent likely failure of the dam.*

Concrete deterioration and cracking approximately 100 feet from the left end of the dam. Continued deterioration will result in failure of the dam in this area.

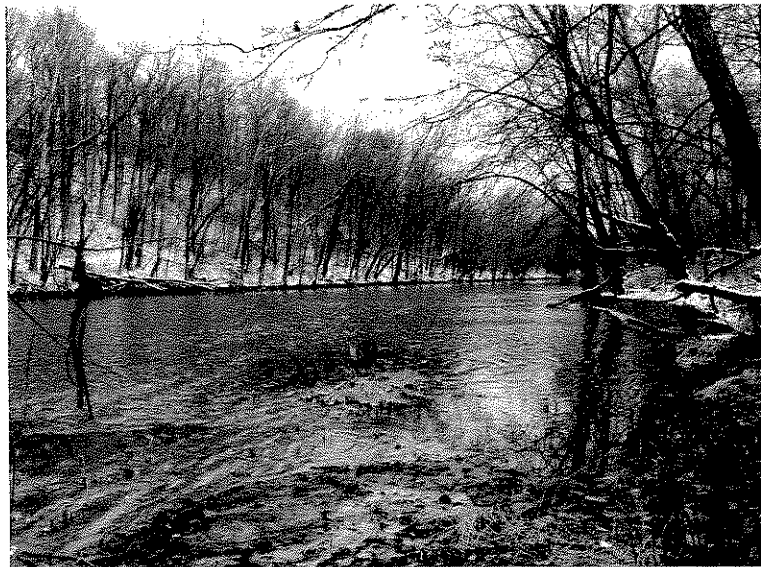
Photograph No. 5:

Downstream river channel.
